Analysis of Land Use Changes Along the Coast of Sidoarjo Beach Due to Rob Flood

Muhammad Dhahlan^{1*}, Niken Ayu Rahma Sudarko¹, Satria Sukananda²

¹ Student of Sekolah Tinggi Pertanahan Nasional, Yogyakarta

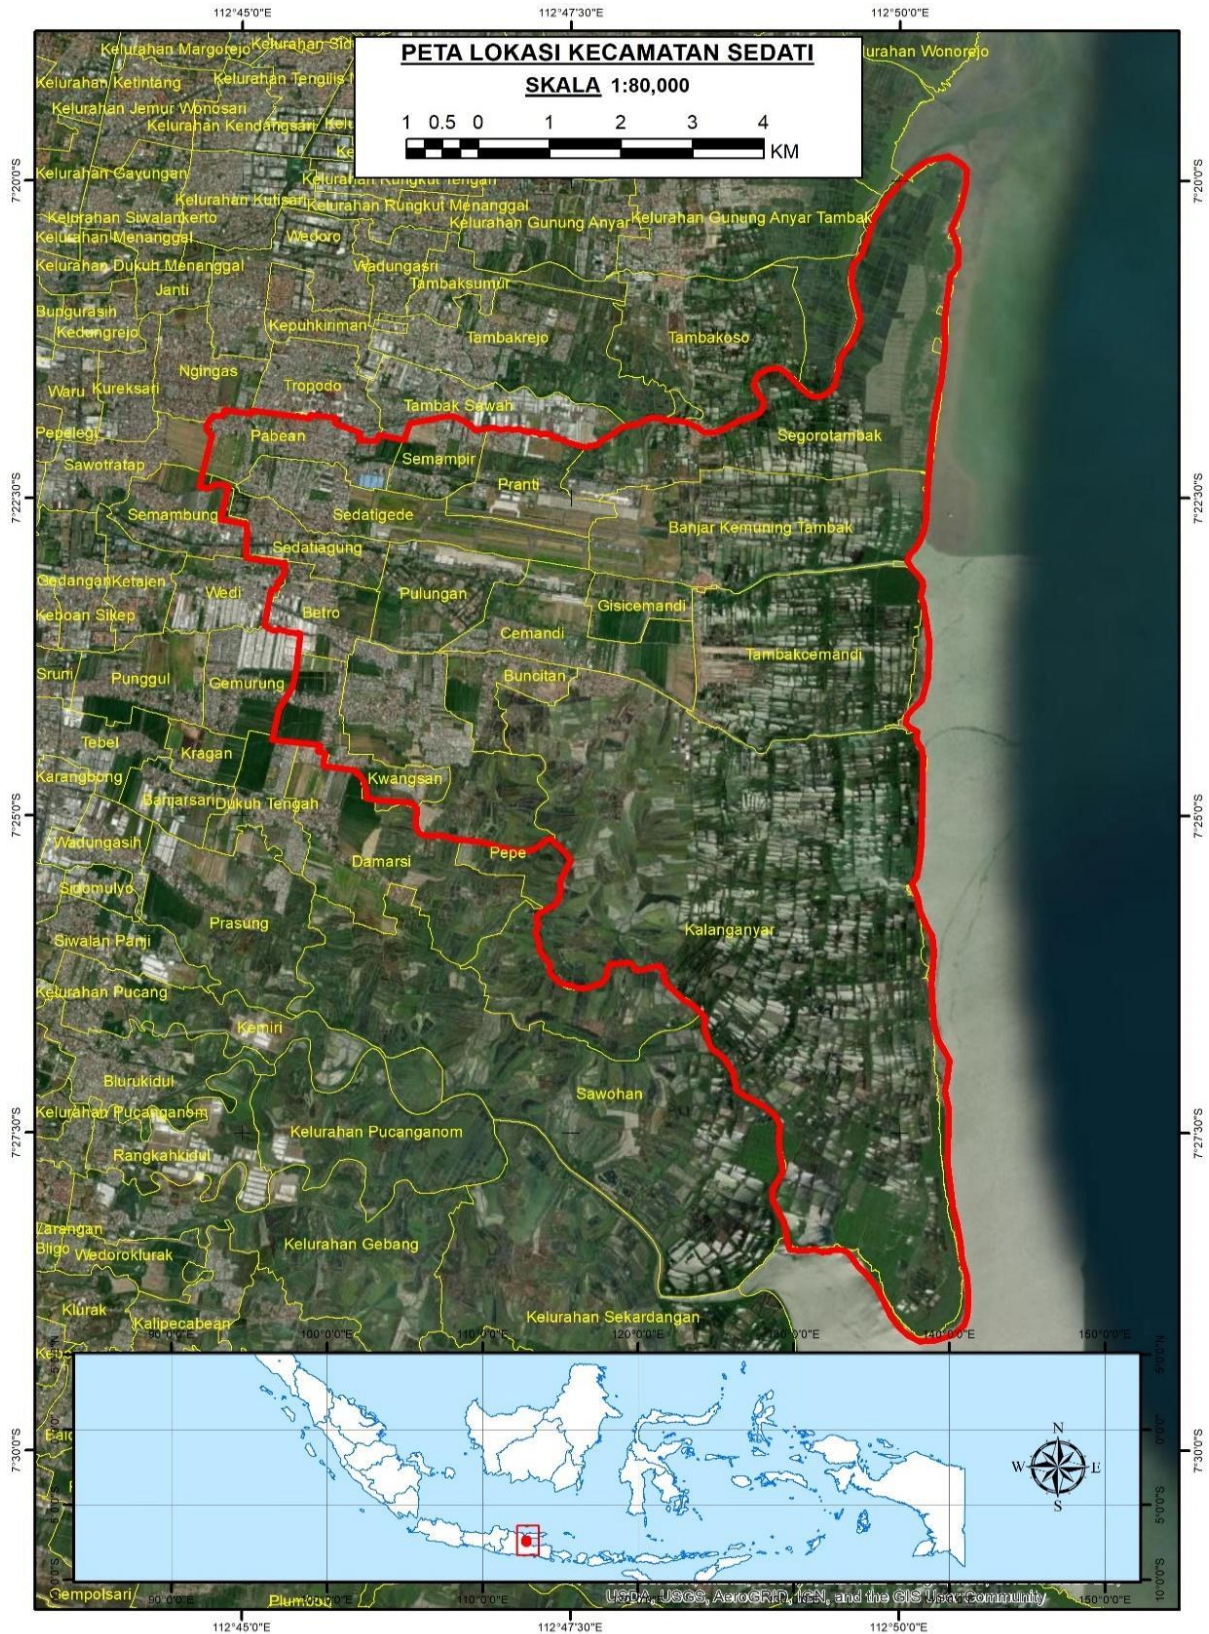
This study was conducted along the coast of Sedati Subdistrict, Sidoarjo Regency with an area of 8,228 hectares and a coastal length of 17,222 meters. Based on the spatial data, Sedati Subdistrict administration area consists of 16 Villages, four of which are located along the coast, namely Segorotambak Village, Banjar Kemuning Tambak Village, Tambakcemandi Village, and Kalanganyar Village. The location of Sedati Subdistrict can be seen from the thick red line in Figure 1 of the location map below, while the yellow line is the administrative boundary of the village/ward.

Figure 1. Location Map of Sedati Subdistrict, Sidoarjo Regency
 Source: Results of map analysis by authors, 2022

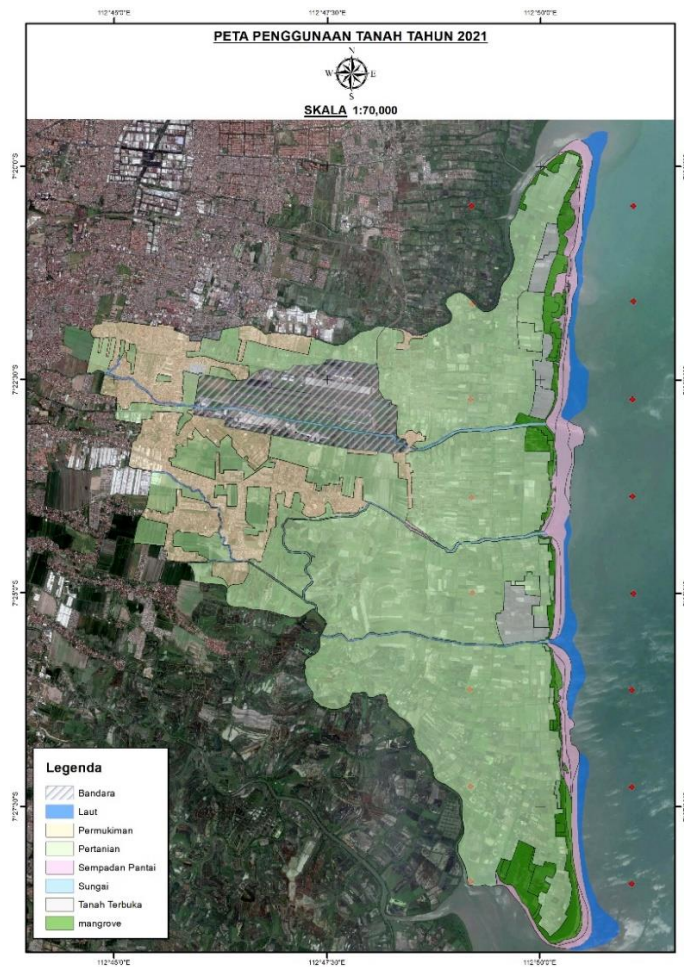
Figures 2c, 2d, and 2e. Map of Land Use in 2018, 2019, and 2021.
 Source: Results of map analysis by authors, 2022

Figure 2c is a map of land use in 2018, Figure 2d is a map of land use in 2019, and Figure 2e is a map of land use in 2021. Figure 2c describes the use of mangrove land in 2018 which is 481.9 hectares, in 2019 the use of mangrove land was 592.5 hectares, and in 2021 the use of mangrove land was 604.7 hectares. The use of agricultural land in 2018 was 5,622.4 hectares, in 2019 the use of agricultural land was 5,601.5 hectares, and in 2021 the use of agricultural land was 5,638.2 hectares.

The use of urban void in 2018 was 385 hectares, in 2019 the use of urban void was 322.7 hectares, and in 2021 the use of urban void was 282.6 hectares. In 2018 the use of coastal region land was 996 hectares, in 2019 the use of coastal region land was 1,142.7 hectares, and in 2021 the use of coastal region land was 859.9 hectares.

From the table above, there is a difference in the amount of land use area between 2015 and 2017 until 2021. This is because in 2015, there was no sedimentation due to the rob flood disaster along the east coast of Sedati Subdistrict. Therefore, in 2017, there was an increase in the area of land use around the coast.

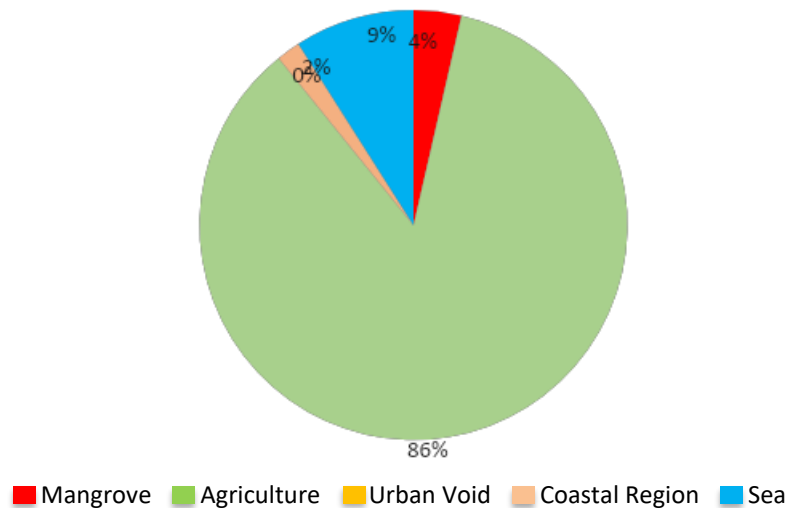
Diagram 1. Percentage of Land Use in 2015

In the 2015 land usage diagram below, it can be seen that the classification of agricultural land predominated in Sedati Subdistrict with a percentage of 85%. Meanwhile, mangrove plants were only 4%, the coastal region was 2%, and the urban void was 0.01%. Land use in Sidoarjo Regency was mostly for coastal areas. The development of coastal areas is also a phenomenon that must be examined. This phenomenon occurs along the shoreline as evidence of a geomorphic process, namely intensive sedimentation (Tajuddin & Ullly, 2018). This shows a huge potential for rob flood around the coastal area.
